## Summer of storms

*The summer of 2017/2018 was notable for unusual – and destructive – weather, as the country was subjected to a series of powerful storms and very high spring tides. In this issue we look at both the reasons behind this unusual weather and the significant impacts it had on New Zealand.*

# The summer of storms – a rare combination of coastal hazard drivers

# January 2018 storm impacts on the Auckland coastline

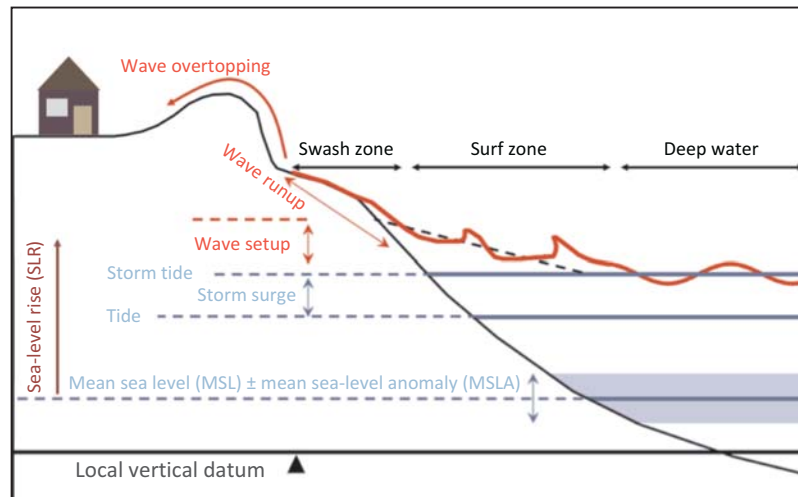
Figure 1: Schematic illustrating the various processes that contribute to coastal inundation.

water level that includes wave setup and runup (Figure 1). The 10,000 years of simulated joint-probability conditions (grey dots, Figure 3), were used to evaluate the total water level from tide + skew-surge + wave setup and runup (using the Stockdon et al. (2006) formulae), and calculated for several beach slopes. For a relatively steep beach with slope 1:10, the total storm-tide + wave setup during Fehi would have a 0.6% AEP (ARI of ~170 years) at present-day MSL, which is more likely than the 0.33% AEP joint-probability of the offshore forcing, but still rare.

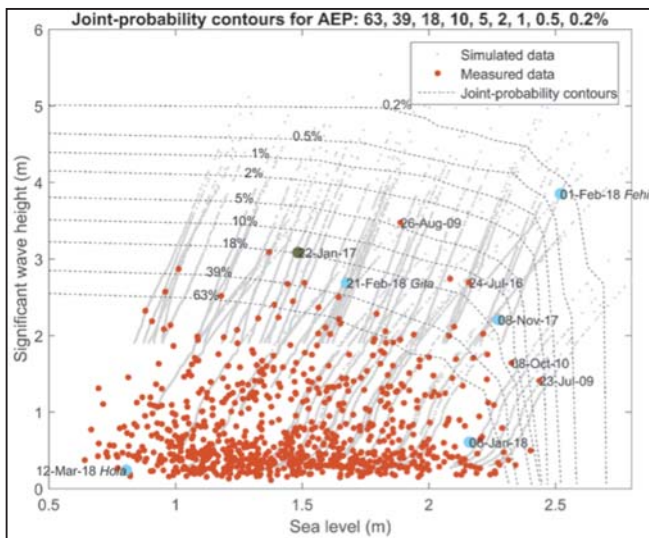
Figure 3: Joint-probability analysis of sea-level measured at Nelson Wharf and wave-height measured at Nelson-Fairway gauge (Stephens et al., 2018). Dashed lines represent joint-probability contours for AEP = 63, 39, 18, 10, 5, 2, 1, 0.5 and 0.2%, from largest (most frequent) AEP on the inside to smallest (least frequent) AEP on the outside. Measured peaks are plotted in red. Events with joint-probability of <18% (>5-year ARI) are dated, and five ex-tropical cyclone events from the 2017-18 summer are coloured light-blue, plus the 22 January 2017 'weather-bomb' event is marked green.

Whereas Figure 2 showed the joint-probability of skew-surge and wave height, Figure 3 shows the joint-probability of the storm-tide and wave height. Once the tide is accounted for (i.e. storm-tide = tide + skew-surge), we see why the 8 November 2017 and Fehi storms were so damaging at Nelson – both had relatively large waves superimposed on unusually high storm-tide sea levels. In Fehi’s case, conditions were very rare at 0.33% AEP or expected once every 300 years on average. The 22 January 2017 weather-bomb event had a relatively rare combination of storm-tide and waves (18% AEP or ARI of ~5 years), but is less-threatening (from a coastal-hazard perspective) once the tide is accounted for, because exposure to wave impact was limited through combination with a lower and relatively-common sea level.

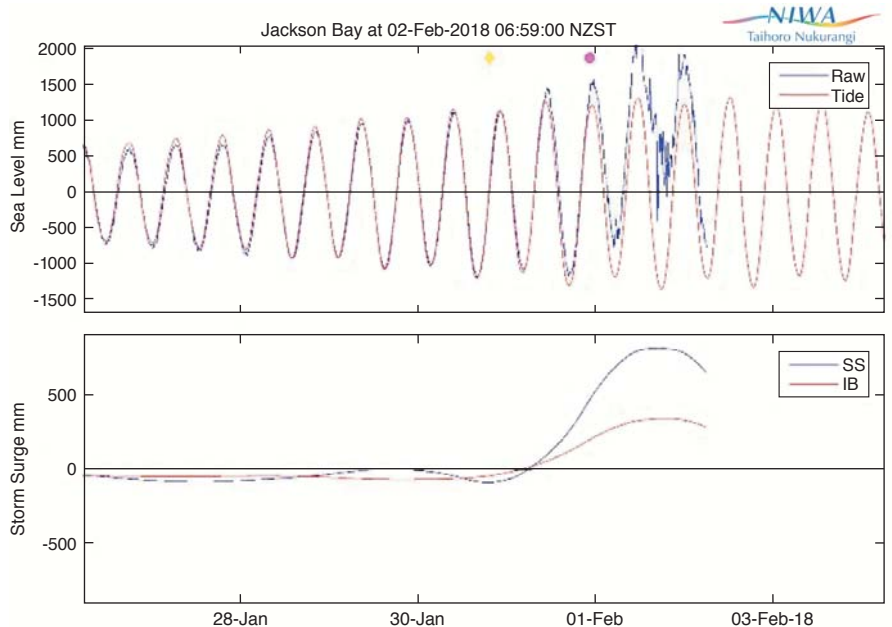
Figure 1: The NIWA tide gauge at Jackson Bay showed the 1 February 2018 sea level disruptions (blue) overlying the predicted tidal cycles (upper plot), and the components of storm surge (bottom plot) caused by inverted barometer effect (IB, red) and storm surge (SS, blue). Source: Jackson Bay tide gauge plots for Jan-Feb 2018, NIWA (NZ) & BoM (Australia).

modelled by marineweather.co.nz and other websites to be over 5 m, and up to at least 10 m as the storm approached the West Coast (Figure 1). These waves were built up over a period of about four days of persistent northerly winds aiming directly at New Zealand's western shores. This occurred as the cyclonic weather system made its way down the Tasman Sea from north-west of New Caledonia. With the height of waves directly related

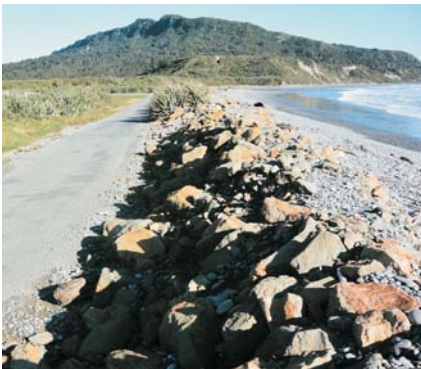
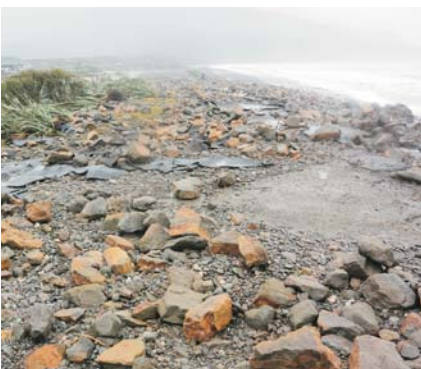
Figure 3: Rapahoe Beach before (top) and after (bottom) Fehi went through (Photo: P Birchfield, WCRC).

Perhaps predictably, places that have a history of erosion and coastal flooding were among the areas worst hit by the storm. Granity-Ngakawau, Carters Beach and Rapahoe were buffeted by waves that crashed over the top of beaches already weakened by ongoing trends of coastal erosion. At Rapahoe, the shorefront roadway was covered by a sheet of beach cobbles thrown high by the waves (Figure 3), and the old Greymouth rubbish dump at Cobden –

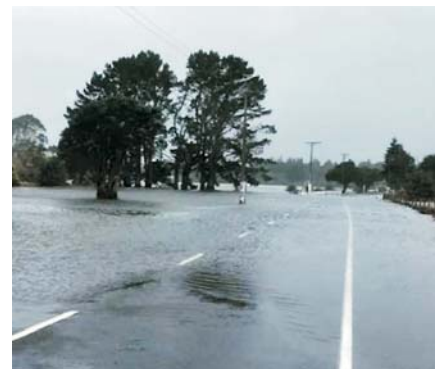
Figure 4: The Orowaiti Lagoon backed up, flooding roads and paddocks near Westport (Photo: Howie Wilson).

As well as damage from storm waves, the elevated sea levels caused flooding problems at some river mouths, most notably at the Orowaiti Lagoon, which backed up and caused flooding as deep as one metre over parts of Westport's residential area (Figure 4). Similar flooding of houses also happened at the lagoon-side village of Okarito and in parts of Greymouth. It wasn't only people that were disturbed by the storm – natural habitats and native species were also badly hit. A small area of coastal dune farmland near Hokitika that was inundated by waves is the only known habitat of the already critically endangered Chesterfield skink. The storm event sparked a rescue effort by DOC to catch most of the remaining lizards for captive rearing, to better secure the species' survival. The Department now has the task of restoring the lizards to their natural home, in conjunction with the adjoining land owner and others.

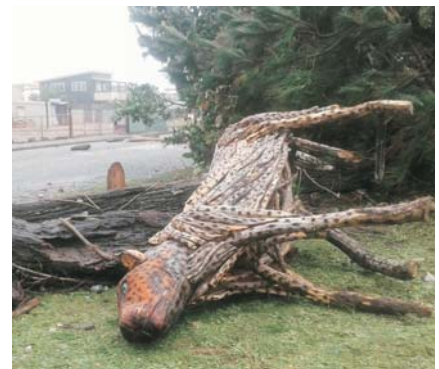
Figure 5: Hokitika's driftwood art took a tumble as waves broke over the seawall (Photo: Don Neale).

Artificial rock seawalls should always be considered as only one option among many for managing coastal hazards, but when they are selected as the best option, there is definite value in ensuring that they are constructed to high standards. Such was the case in Hokitika, where the carefully-built 2013 seawall mostly withstood the storm's attack, despite some wave overtopping that caused a limited amount of damage to beachfront properties (and to the driftwood art created the week before in an annual community event! (Figure 5)).

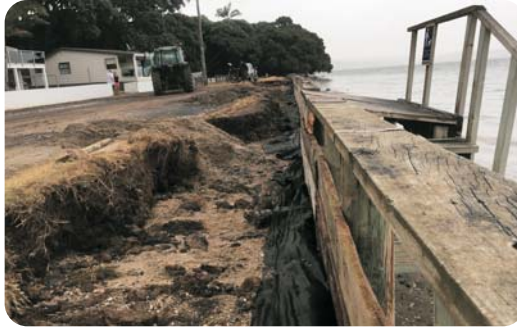
(R) Figure 3: Clarks Beach, Manukau Harbour, 7 January 2018 (Photo: Jo Morriss, Auckland Council).

Due to fetch exposure, storm conditions resulted in significant overtopping of an existing timber seawall. Resulting scour behind the seawall caused failure and collapse of the structure. The seawall is to be rebuilt and realigned further landward (Figure 3).

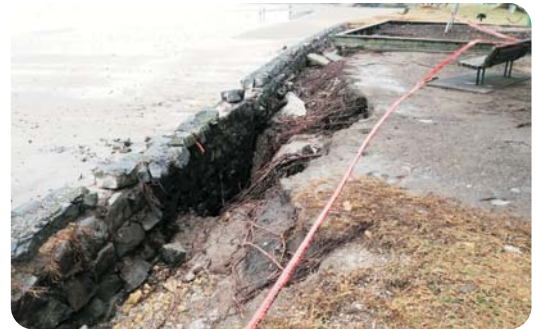
(L) Figure 4: Scandrett Regional Park, 5 January 2018 (Photo: Beckie Trigg, Auckland Council).

Significant damage to the road that provided access to bach accommodation on the park (Figure 4). The road is to be relocated to a landward position, and the coastal edge restored.

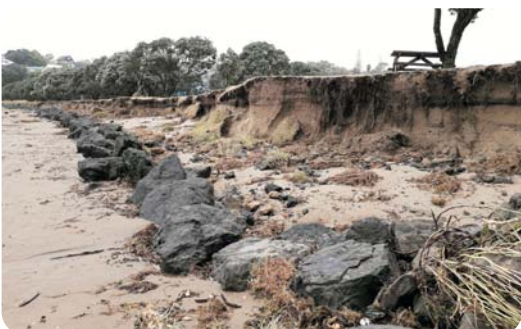
(L) Figure 7: Stanmore Bay, outflanked rock armouring and eroded reserve edge, 5 January 2018 (Photos: Paul Klinac, Auckland Council).

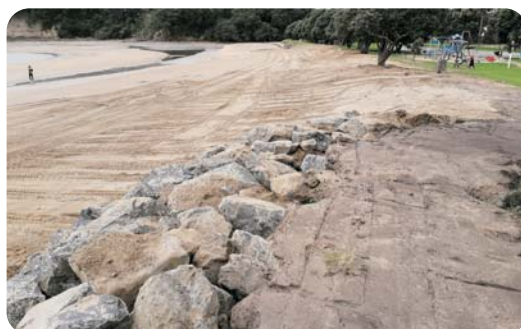
(R) Figure 10: Reconstructed rock revetment in front of toilet block (Photo: Matthew McNeil, Auckland Council).

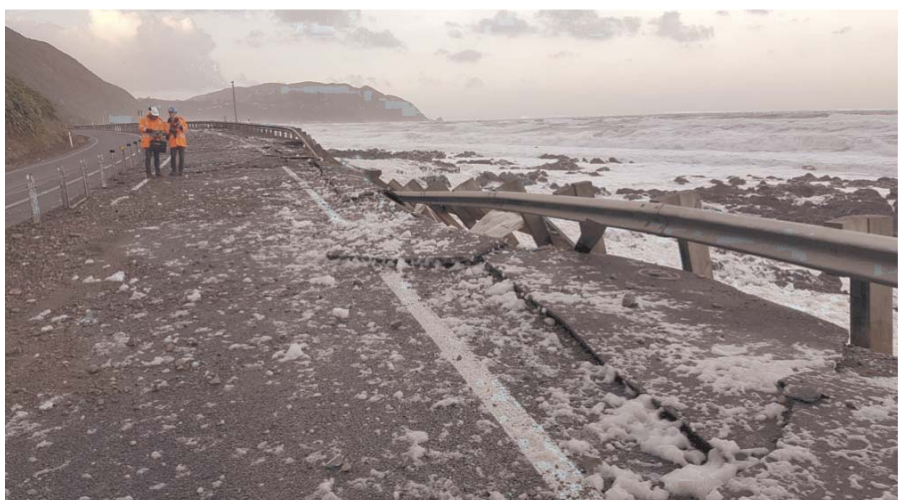
Figure 2: Damage to road infrastructure on the Coast Road (SH1) north of Wellington after ex-cyclone Gita (Photo: WSP Opus).

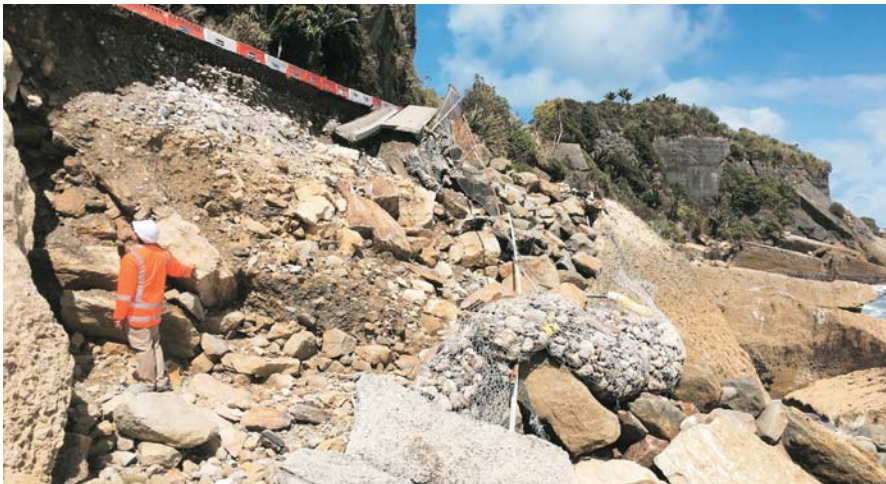
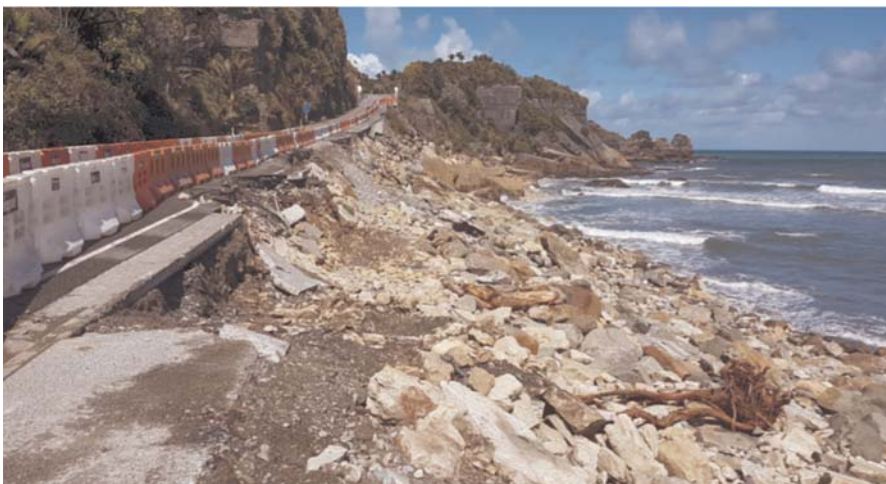
Figure 4: Punakaiki section (SH6) damaged after ex-tropical cyclone Fehi (Photo: WSP Opus).

Figure 5: Punakaiki section (SH6) damaged after ex-tropical cyclone Fehi (Photo: WSP Opus).

At SH6 sites, an initial stability assessment allowed the road to be re-opened to traffic under a one lane restriction (this was necessary to move live loading away from the seaward edge of the highway). Subsequent short-term stabilisation was provided by the importation and placement of fill seaward of the damaged section of the revetment. The long-term risk management approach comprises an engineered erosion risk management solution to protect the road pavement from damage in a similar magnitude future storm event. Due to the low traffic volumes on the road, NZTA

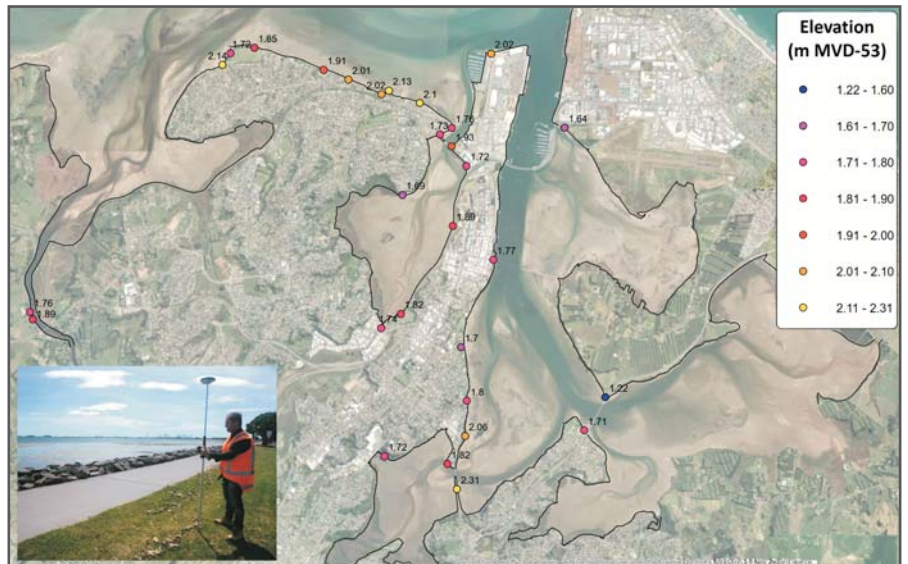
Figure 3: Location and elevation of debris lines recorded after the 5 January 2018 event.

Development of the extreme water level prediction tool demonstrates how observational data, such as debris line elevations, provide not only useful information for increasing our understanding of individual events, but also can help with preparing for future events. Extreme water

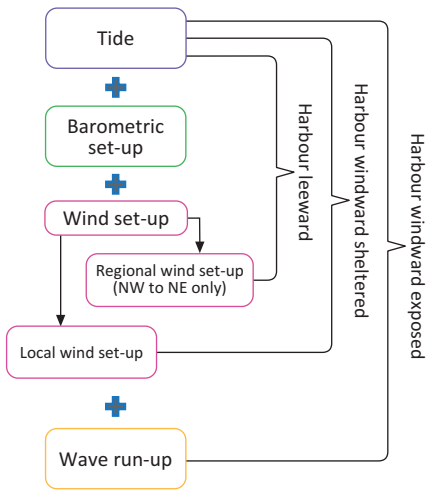
Figure 4: Schematic diagram of the parameters used to predict extreme water levels for different locations.

The tool estimates the contribution to water level elevation for each component based on a combination of empirical formula and/or observations for the 5 January event, and combines the components to obtain a total water level. The resultant extreme water levels are highly dependent on the direction of wind and hence vary dependent on shoreline orientation and location. For example, during the 5 January event, the exposed windward, north-facing shorelines were influenced by local wind setup (i.e. tilting of the water surface within the harbour) and additionally by wind-induced wave setup and wave run-up, whereas in sheltered, southern parts of the harbour there were no wave effects, but the local wind setup elevated water levels above the recorded storm tide. In leeward shorelines along the northern parts of the harbour the inundation level was driven entirely by the storm tide level. Based on these differences in the driving components, the extreme water level can be estimated for three different shorelines orientations, leeward, windward (sheltered), and windward (wave-exposed), as shown in Figure 4.

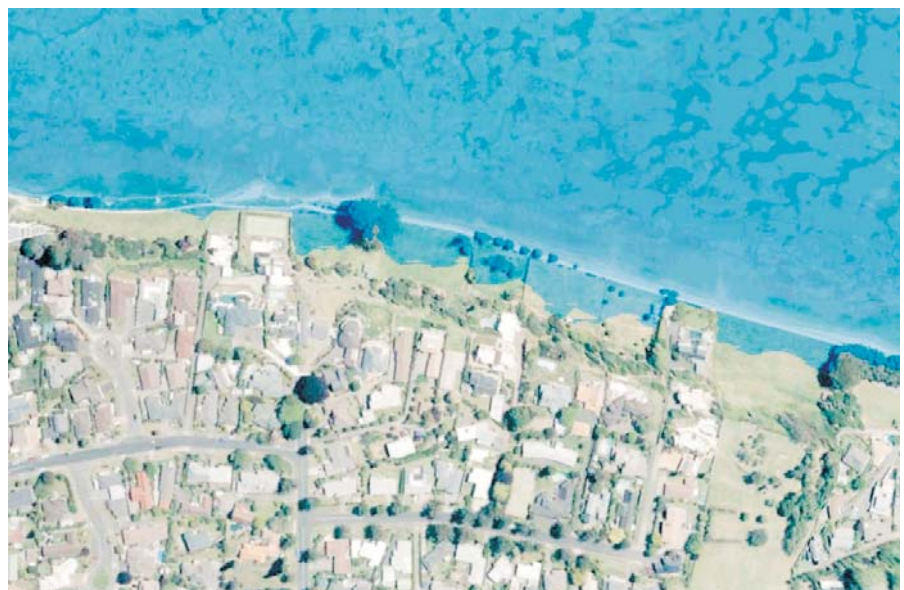
Figure 6: Example of bathtub inundation using extreme water level predictions (2.1 m MVD) and 2015 LiDAR.
